# Committee Report

<b>To:</b>	Warden McQueen and Members of Grey County Council
<b>Committee Date:</b>	April 23, 2020
<b>Subject / Report No:</b>	TR-CW-11-20
<b>Title:</b>	Additional Funding for Structural Monitoring
<b>Prepared by:</b>	Matt Marck, Engineering Manager
<b>Reviewed by:</b>	Pat Hoy, Director of Transportation Services
<b>Lower Tier(s) Affected:</b>	Town of the Blue Mountains
<b>Status:</b>	Recommendation adopted by Committee as presented per Resolution CW81-20; Endorsed by Council May 14, 2020 per Resolution CC50-20;

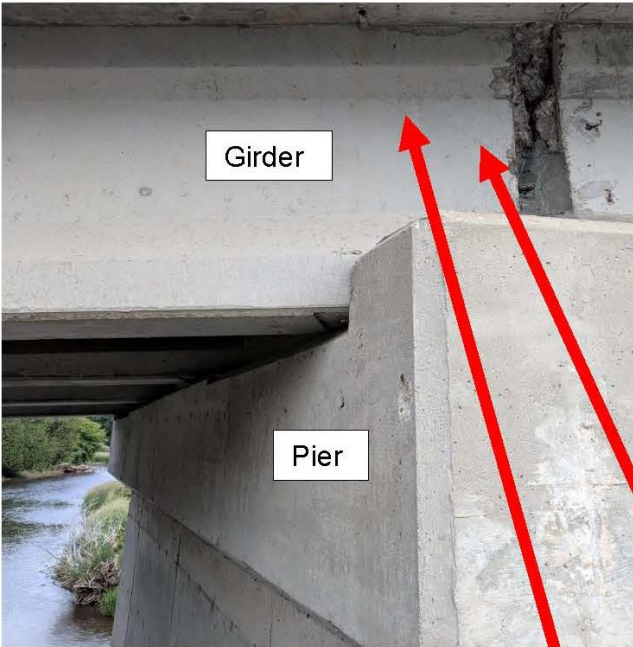
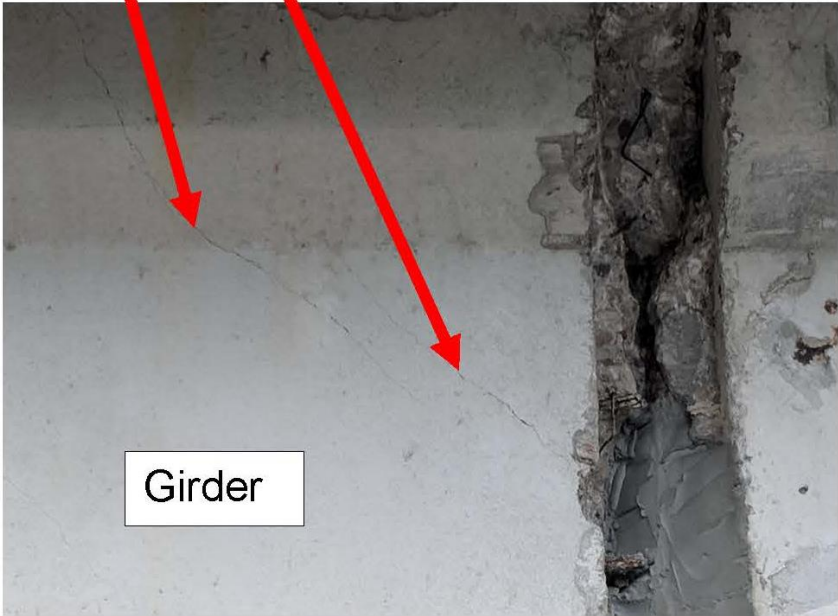
Photograph of Structure 013-092 Shear Cracks (Typical of all girders)

In the summer of 2018, the Grey County Bridge Crew noticed cracks in the concrete girders of Structure 013-092, which is located on Grey Road 13 in the Town of The Blue Mountains.

Further investigation by two different engineering firms gave similar opinions about the cracks. Both indicated they were shear cracks. They both gave an opinion that to mitigate the concern, a carbon fibre wrap should be applied on the bridge beams. The two firms differed as to timing with one noting they were not a significant structural concern at the time but should be monitored yearly, and the other indicating it should be addressed in the near future.

Transportation Services would like to secure funding from the Transportation Services General Reserve to load test and perform monitoring consisting of placing gauges and sensors on the structure to record data that will determine how serious, if at all, the cracks are, and the timing of a repair.

Struct-Sure Infrastructure Monitoring Solutions would implement an OSMOS Structural Health Monitoring sensor system to monitor structural behaviour and ultimately verify the structural integrity and stability on an ongoing basis. The high accuracy of this system allows it to detect strain in the structure, which would not produce visible deformations or cracks. This strain is brought on the structure due to environmental conditions, seasonal temperature changes and external loading.
